Qualifying EXO Turbidity Sensors for LED Drift

Some EXO Turbidity Sensors manufactured between March 2019 and July 2021 exhibit an unusually high level of drift during deployments.

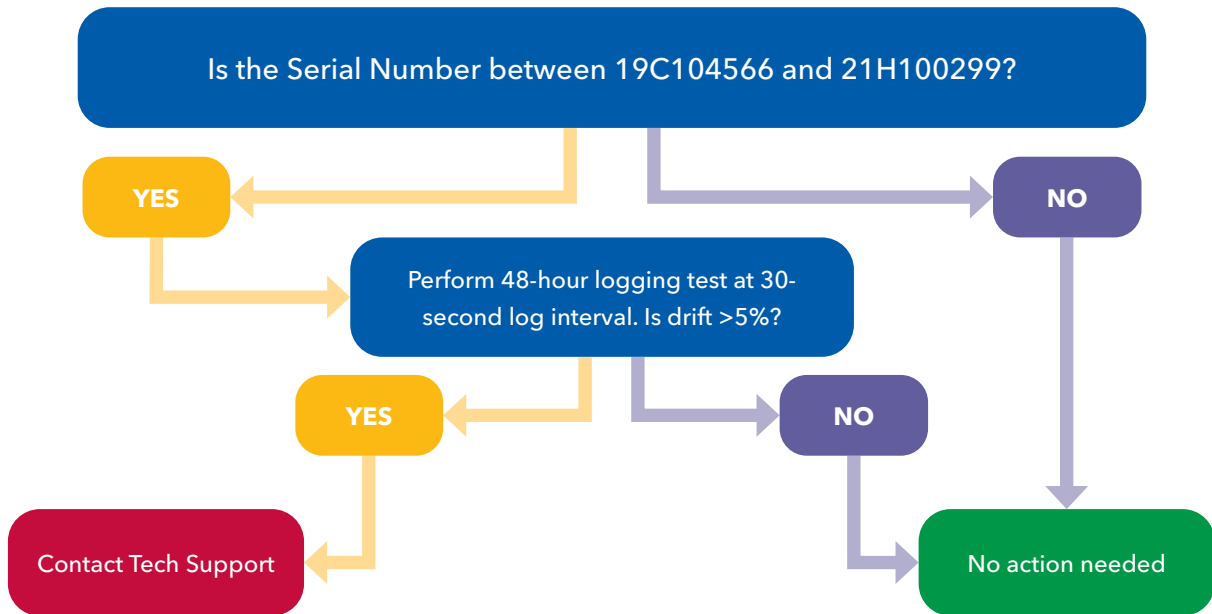
Sensors at risk of being affected fall into the serial number range between **19C104566** and **21H100299**. If the sensor serial number is outside of this range, no further action is needed because the sensor does not contain one of the potentially affected LED's.

If the sensor is within the range, we must determine if it is experiencing irregular drift. Remember, *not all sensors within this range are affected*. A 48-hour rapid logging test is necessary to evaluate sensor performance. This flow chart will provide guidance for determining if your sensor is affected by irregular LED drift:

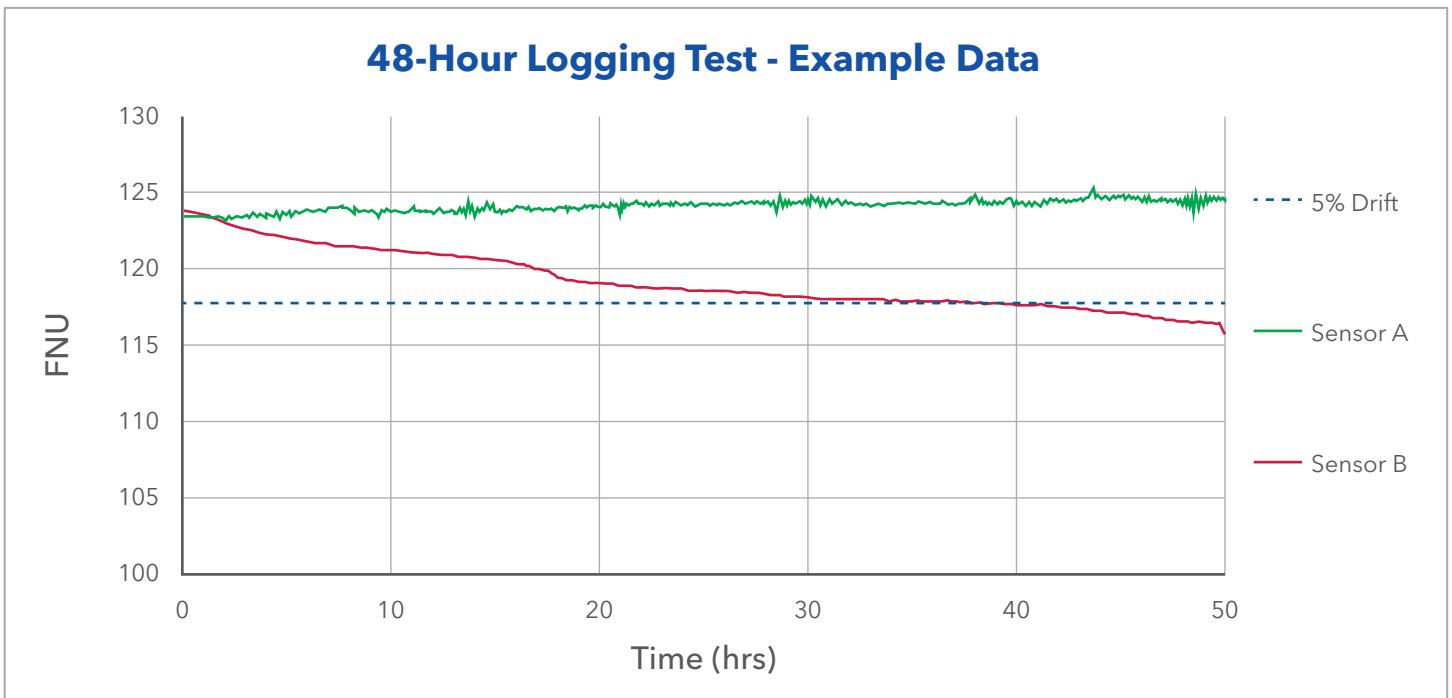
If the drift is greater than or equal to ±5% then the sensor may be affected and you should contact YSI Tech Support.

Data from a relatively stable sensor (A) compared to a sensor exhibiting irregular drift (B).

Before you go through the effort of shipping us the affected sensor(s), please contact YSI Technical Support [**800-765-4974** or info@ysi.com] to initiate the return for replacement.

Turbidity sensors, ranging from **19C104566** and **21H100299**, returned to the Repair Center will not be charged an evaluation fee. Once irregular drift is verified, the sensor will be replaced under warranty.
