# Preliminary Assessment of Water Quality in Riviera Grise near Port-Au-Prince, Haiti

## YSI Multiparameter Handheld, Haiti Application Note A605

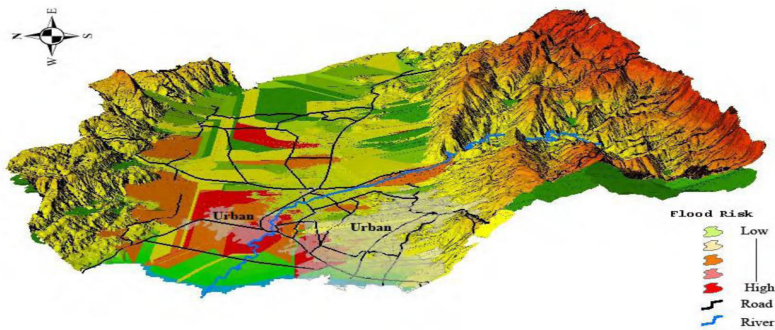
Flood risk map of Cul-De-Sac watershed showing the extent of erosion in the flood plains if Riviera Grise, Port-Au-Prince, Haiti.

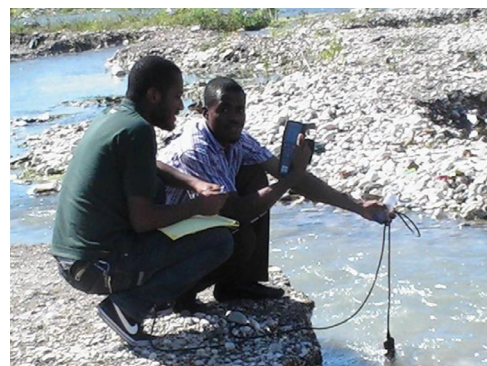
FAMV students using the YSI Pro Plus multiparameter water quality instrument in the Riviera Grise near SUH, FAMV campus. Students monitor basic parameters under the supervision of Dr. Nedunuri.

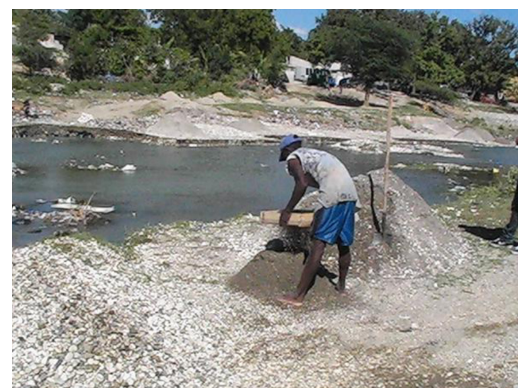
The section of the river surveyed is approximately 2 km from FAMV and drains water from agricultural lands close to FAMV. Visual observations indicate the river habitat is severely impacted by artificial

channelization. The river carries a lot of sediment which is being manually removed from the river bed to the banks to sieve gravel from silt. Local residents collecting the gravel sell it for construction purposes. The river is losing significant substrate at the same time providing livelihood to the poor people who are surviving on the river. There is no riparian

Riviera Grise experiencing artificial channelization as gravel and silt is manually removed.

A collaborative effort may be sought among the scientists at FAMV, CSU and FAMU to establish riparian corridors to restore natural conditions of the stream. Such a restoration of natural habitat may sustain the aquatic ecosystem in the river. It will also improve the stream quality and fish production. People could then find alternate means for livelihood without disturbing the natural environments of the river and its surroundings. Steps should be made to encourage poorer people living in heavily populated city
