# IRRIGATION EFFICIENCY CRUCIAL FOR ENSURING SUSTAINABLE WATER RESOURCE

WALEED ALI <sup>(1)</sup>, DANIEL WAGENAAR<sup>(2)</sup>

<sup>(1)</sup> Murrumbidgee Irrigation, Griffith, NSW, Australia, Waleed.Ali@mirrigation.com.au

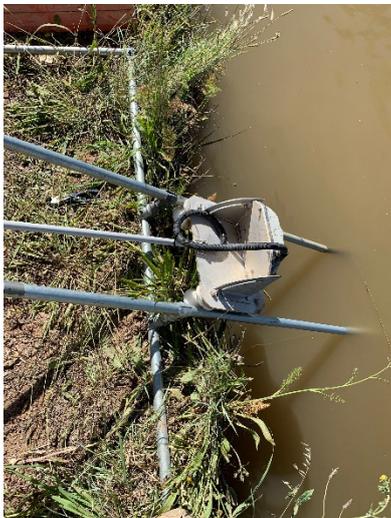
**Figure 4:** SL1500-3G deployment.

ADVM (SL1500-3G) instruments were installed at each of the 9 measurement sites identified for flow verification, illustrated in Figure 4. The SL1500-3G was mounted on a sliding mount secured in between two sliding rails on the side of the channel, shown in Figure 5. The sliding rails were fixed in place by a steel frame secured to a 500L road barrier filled with water. The mounting system allows for quick installation without the need for establishing permanent infrastructure or modification to the existing channel lining. The design of the mounting system makes it easy to redeploy at other measurement sites and perform maintenance on the instrumentation.

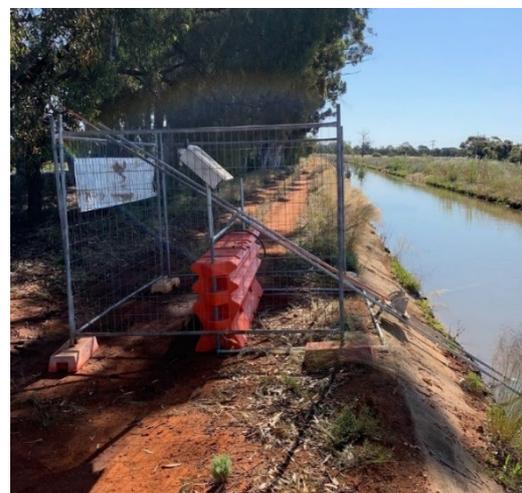
**Figure 5:** Temporary SL1500-3G Mounting Frame.

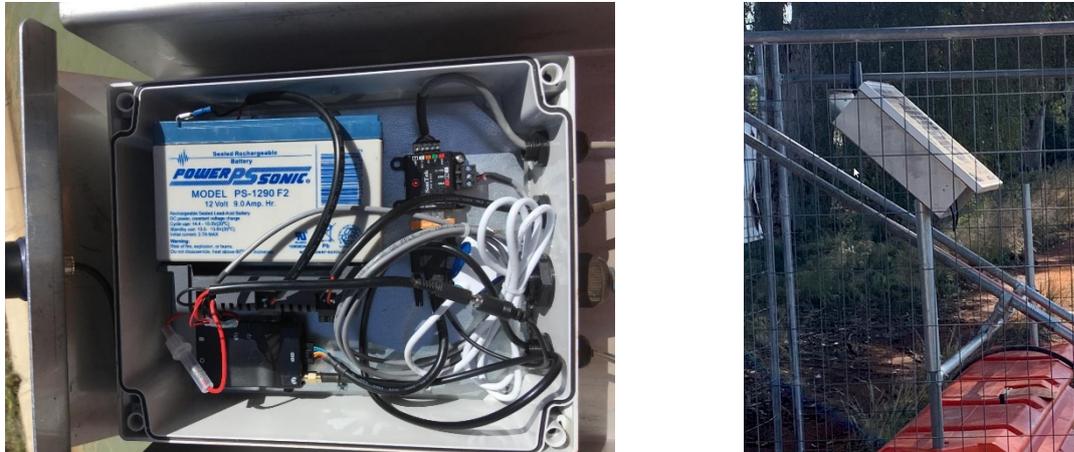
**Figure 6:** Junction Box for Housing Electronics

The telemetry equipment and power supply was housed inside a junction box (refer to Figure 6) which included:

- NTC-100-01 4G LTE CAT M1 Serial IOT device: to collect serial data from the SL and send it to MI's database in real-time
- 12V battery: to provide power the SL1500-3G and IOT device

The junction box was mounted inside a stainless-steel frame, with a 20 W solar panel attached on top of the frame to charge the battery.

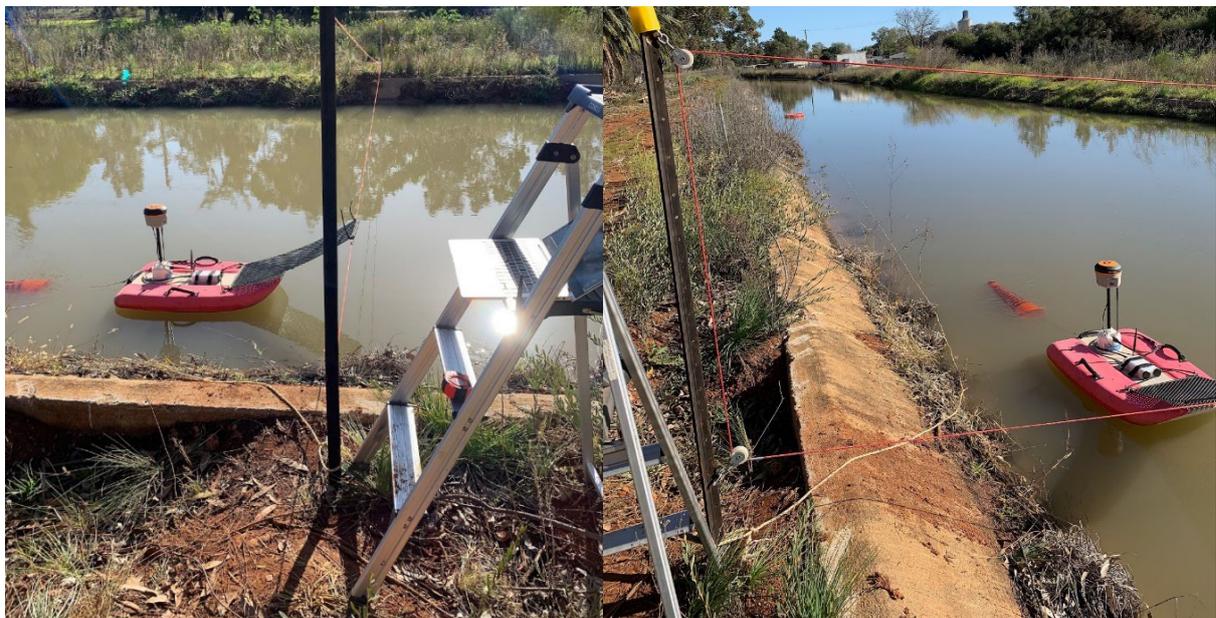
**Figure 7:** Cableway Design at each Measurement Site for ADCP Discharge Measurements.

ADCP (RiverSurveyor M9) cableway's were installed adjacent to the SL1500-3G installation's at each of the measurement sites. The cableway allow a single operator to perform an ADCP discharge measurement with RiverSurveyor M9, shown in Figure 7. The use of a cableway improves the overall accuracy of the discharge measurement by achieving a more constant boat speed while traversing across the channel. A plastic mesh was used to attach the Hydro-board to the cableway at two points, thus reducing lateral movement on the Hydro-board and minimised the variance in discharge measurement results.
