# YSI Turbidity Sensor Stability

## Typical Drift in Field Studies

Occasionally, YSI Technical Support is requested to provide information on what can be expected with regard to the long-term drift of our 6026 and 6136 turbidity sensors. This document is designed to meet this need.

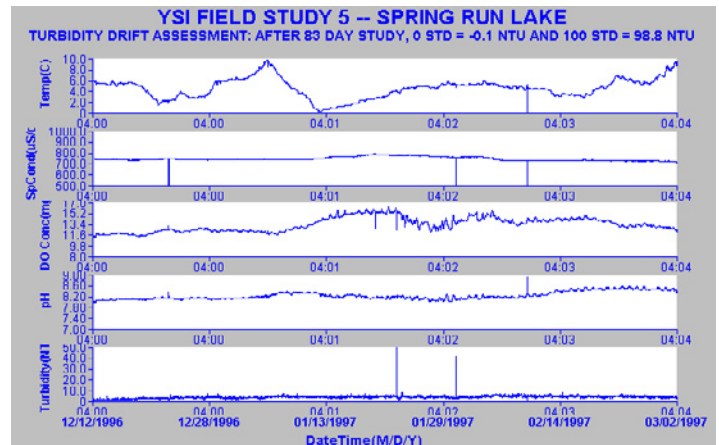
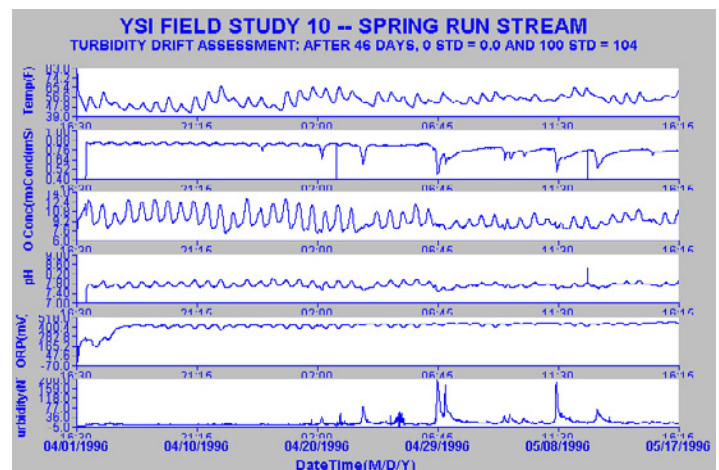
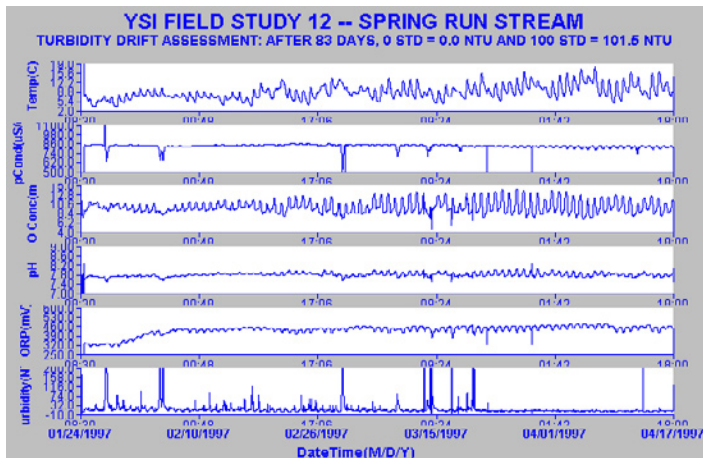
To supplement the information shown in the table, the actual plots of turbidity (and all other parameters monitored in the studies) vs. time are shown below for Studies 5, 10, and 12. The noise level and occasional spikes shown in the plots for the field studies are also typical of the YSI turbidity probe performance. Also note the excellent inverse relationship shown between turbidity and specific conductance during the frequent rainfall events in studies 10 and 12.

The data indicate that the long-term drifts are usually <3 % and this behavior has been typical for our turbidity sensors in all of our other studies since the 6026 was first introduced in 1995. Note that the standard itself is only certified to +/- 2 %, so it is possible that there was even less drift than is shown.
