YSI Turbidity Sensor Stability

Typical Drift in Field Studies

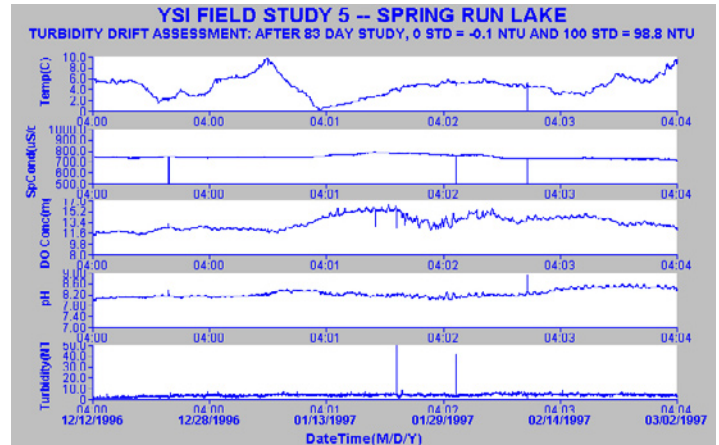
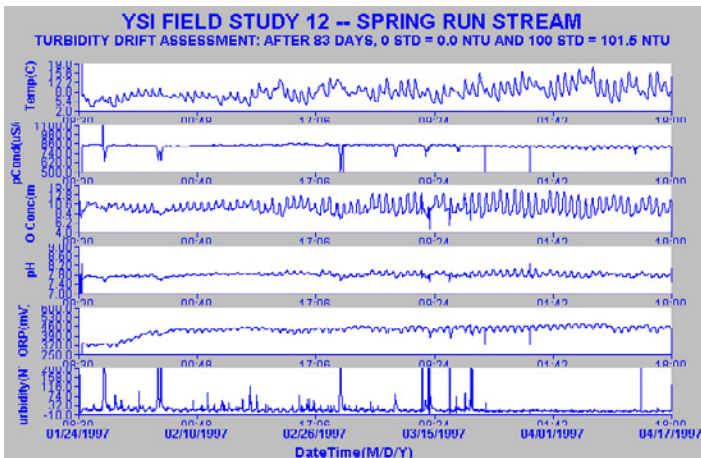
To supplement the information shown in the table, the actual plots of turbidity (and all other parameters monitored in the studies) vs. time are shown below for Studies 5, 10, and 12. The noise level and occasional spikes shown in the plots for the field studies are also typical of the YSI turbidity probe performance. Also note the excellent inverse relationship shown between turbidity and specific conductance during the frequent rainfall events in studies 10 and 12.

(continued)
