Installation of Firmware Updates for OmniSat-1 GOES Transmitters

FIRMWARE UPDATE: OMNISAT-1 / H-22DASE

OmniSat-1 / H-222DASE
GOES Transmitter

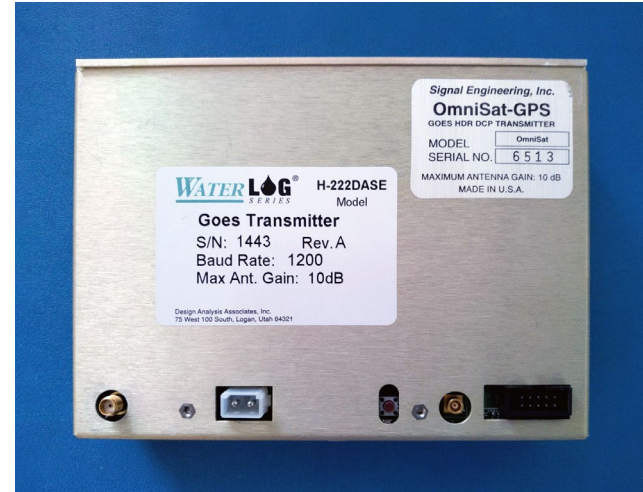
YSI's WaterLOG/Design Analysis brand of GOES transmitters, model H-222DASE, were manufactured by Signal Engineering. These transmitters could potentially be branded either **H-222DASE** or **OmniSat-1**. The transmitter will be referred to as the *OmniSat-1* in this document.

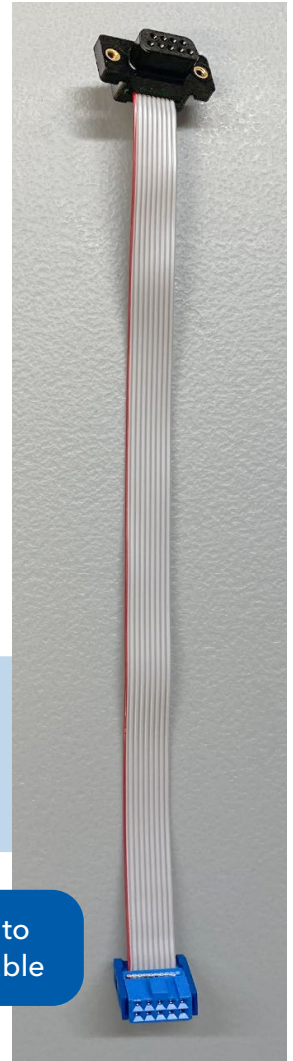
A PC Data Cable for an OmniSat-1 will typically consist of a 9-pin female D-sub connector (to connect to the PC's 9-pin serial port) and a 10-pin ribbon cable connector (to connect to the OmniSat-1) and a length of AWG 26 or AWG 28 flat ribbon cable (0.5 meter to 1 meter in length) with the same number of conductors as the number of pins in the OmniSat-1 control interface connector. Most H-222DASE transmitters will have a short 10-pin to serial cable already in use, this cable can be used for this firmware update (**see image: top right**).

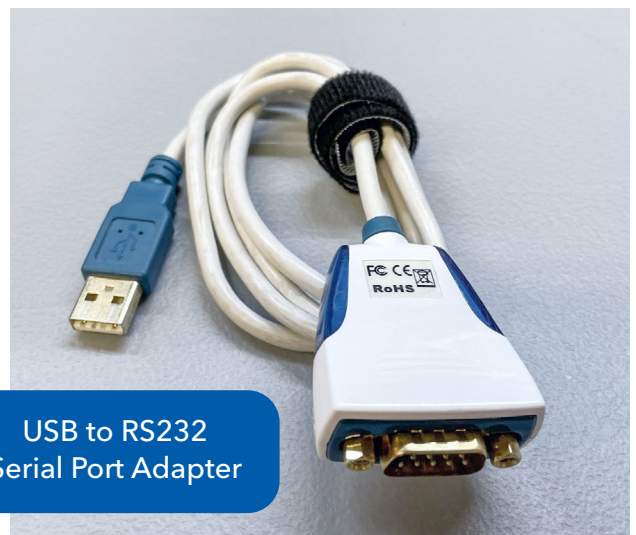
USB to RS232
Serial Port Adapter

If the PC to be used does not have either a built-in RS-232 serial port or a serial port on a PCI or PCIe plug-in card, a USB-to-RS232 serial port adapter will be needed. In addition to the normal RS-232 Signal Ground, Transmit Data and Receive Data signals, the adapter must also support the RS-232 RTS and CTS control signals.

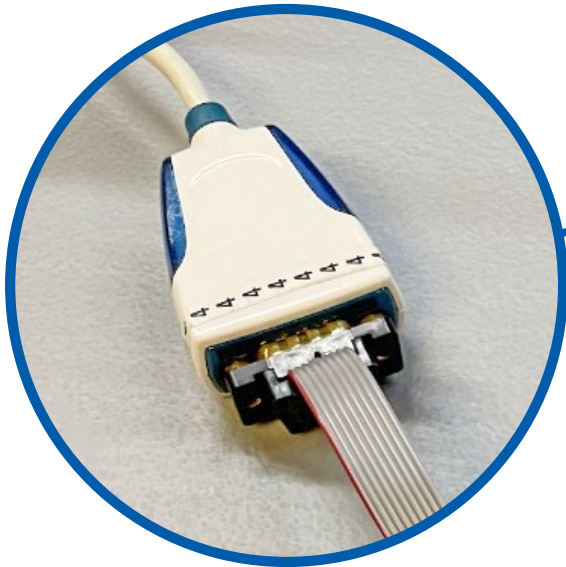
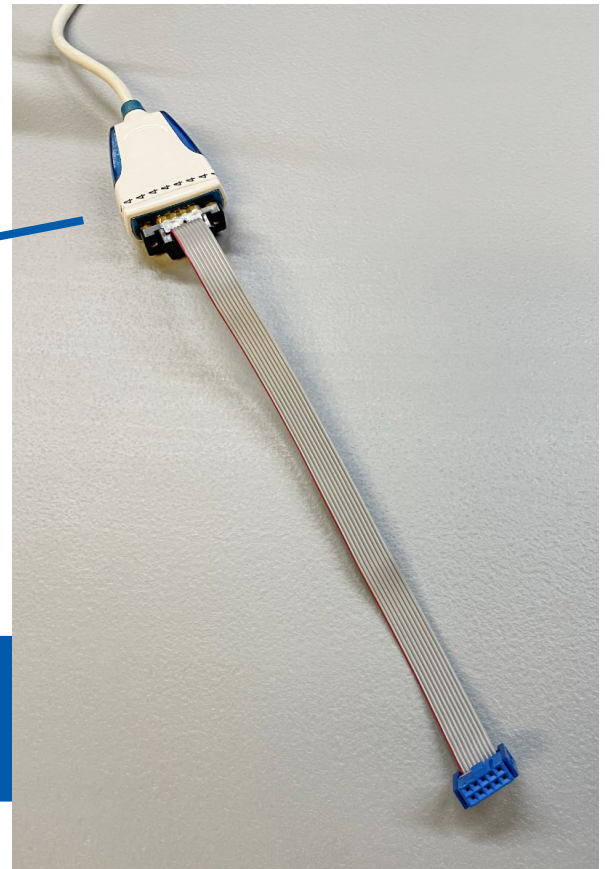
10-pin to serial cable connected to USB to serial adapter.

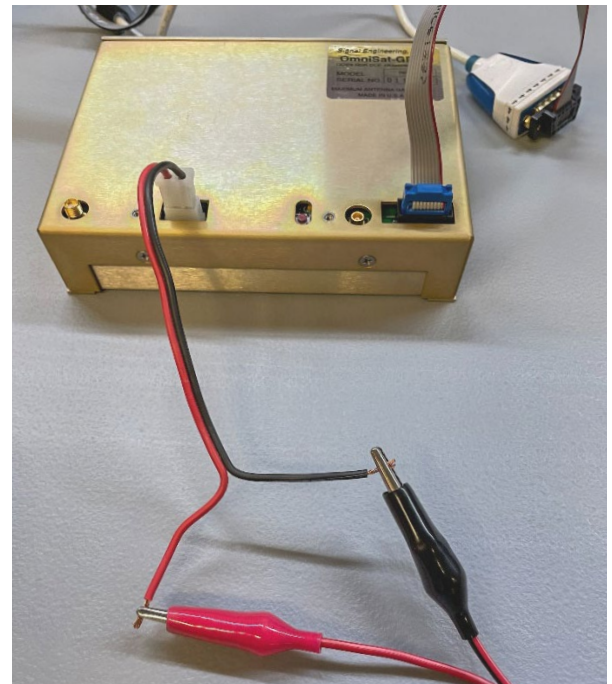
Connect the PC serial port to the OmniSat-1 control interface connector using the data cable.

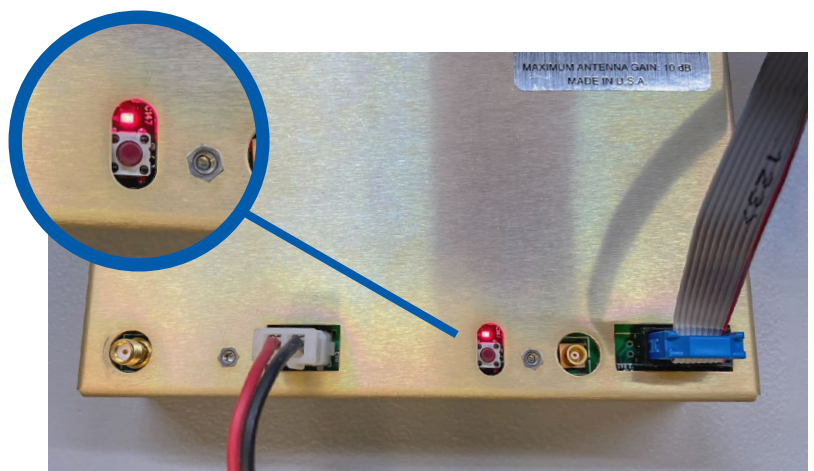
When power is applied to the OmniSat-1, the red LED next to the Failsafe Reset pushbutton switch will **blink 2 times** to indicate that the Main (RS-232) firmware image is running and the RS232 interface is enabled.

If the LED blinks 6 times, this indicates that the Bootloader firmware image is running and the Main firmware is missing or corrupt and needs to be reloaded. Wait until the LED finishes blinking its pattern before continuing.

NOTE: If the LED blinks 4 times after power on, this indicates that the HSB firmware image is running and the HSB control interface is enabled (and the RS-232 interface DISABLED). The procedure described here does not apply to OmniSat-1s with their HSB interface enabled.

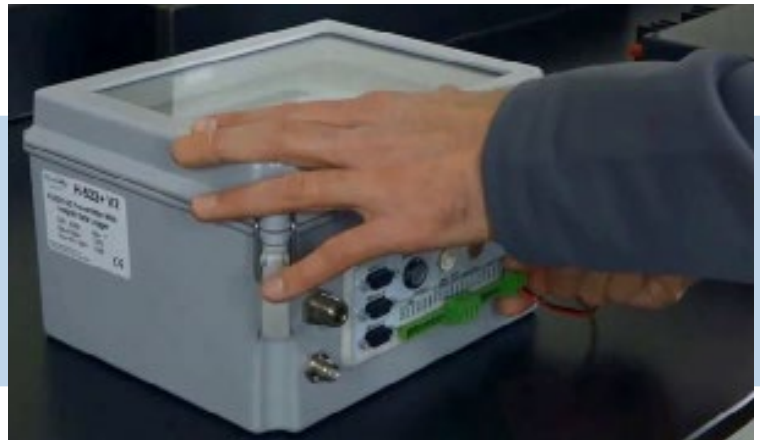
Remove the power supply from the main terminal on the bottom of the datalogger.

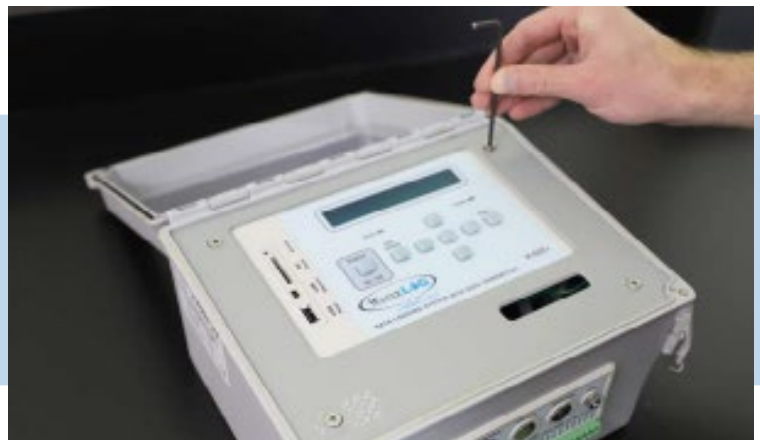
Remove the 4 screws using a 1/8" Allen wrench. You may need to puncture or remove the Void Warranty sticker.

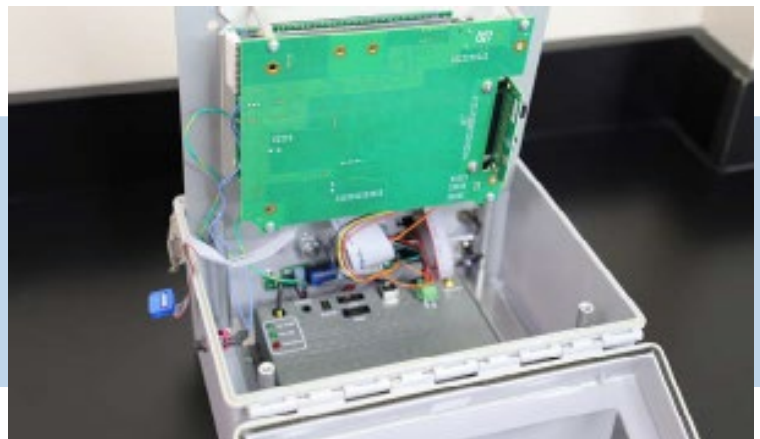
Lift up the display panel and carefully wedge it between the standoffs and the bottom of the enclosure as shown.

The "Host" ribbon cable can be unplugged for more wiggle room.

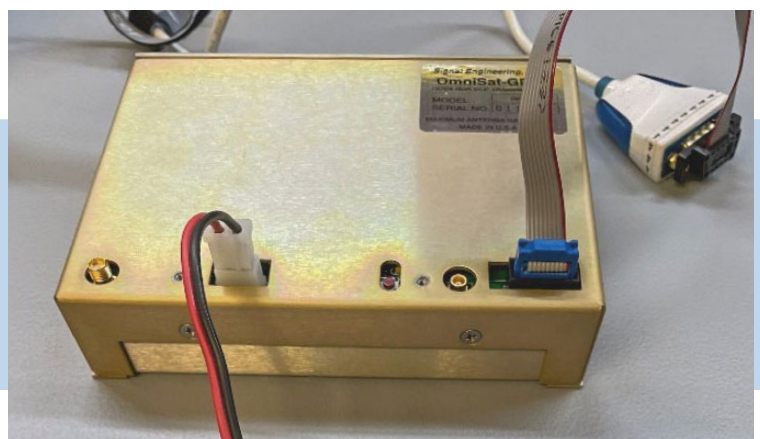
Remove the power cable from the terminal on the transmitter. Then plug the Serial to 10-PIN cable into the 10-PIN port on the transmitter and a PC containing the H-222DASE Firmware Update utility.

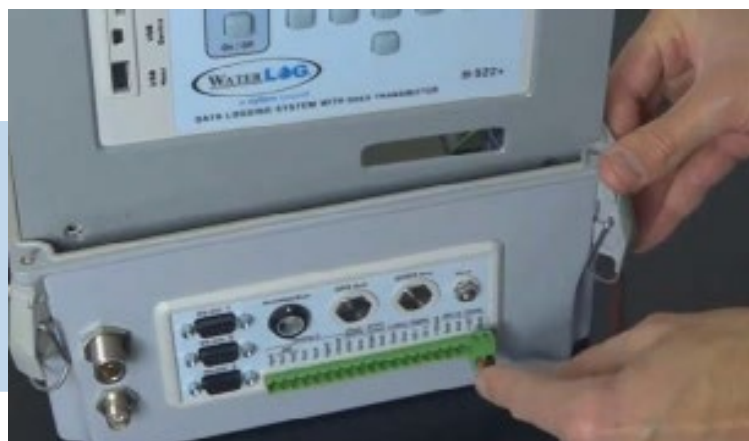
Apply power back to the main terminal on the bottom of the datalogger.
