6-Series Anti-Fouling Kits

*Prevent Biofouling,
Extend Long-Term Deployments*

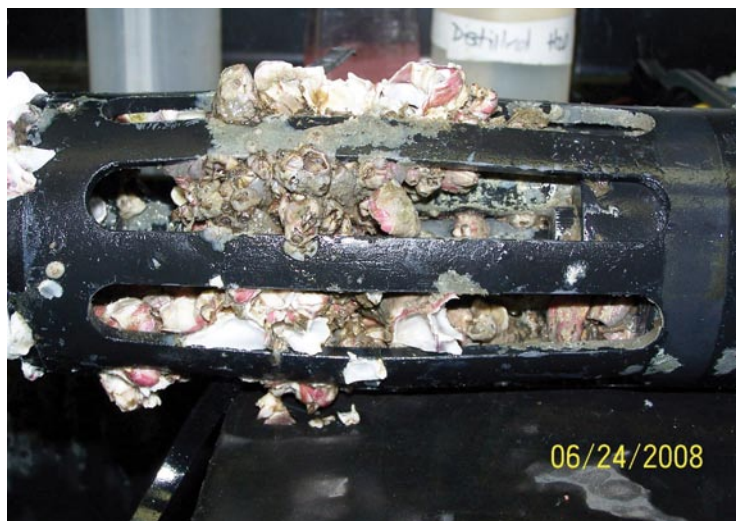
Biofouling on a YSI 6600EDS sonde deployed in the Gulf of Mexico for ~60 days. This picture documents what can happen when sondes are deployed in severe fouling situations and not recovered in two weeks or less. *Photo by Lora Pride, LUMCON.*

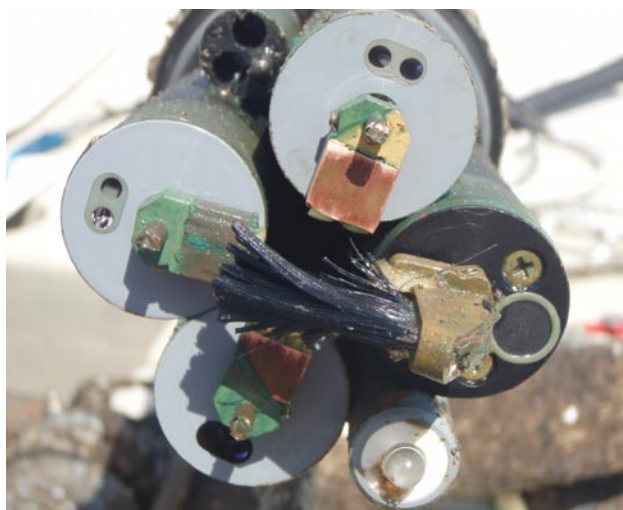
“AF Test Sonde” YSI 6600 V2-4 sonde deployed in the Gulf of Mexico for approximately 17 days. This 6600 was fitted with the just-released copper-alloy Anti-Fouling Kit. Fouling was eliminated from the critical measurement areas on the sensors. *Photo by Sherryl Gilbert, USF.*

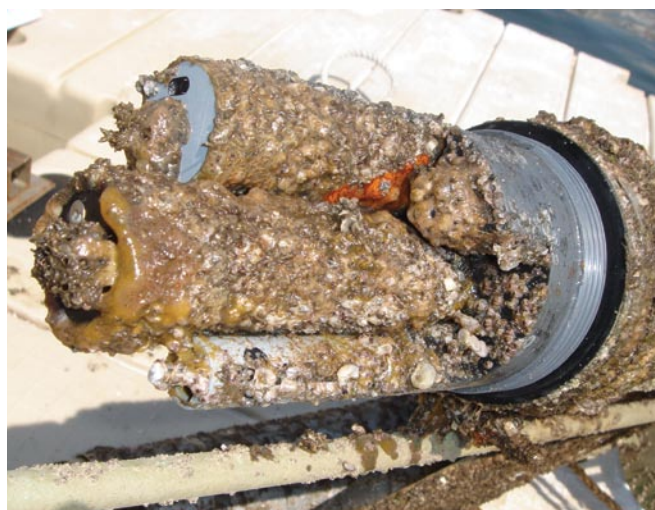
“Control sonde” YSI 6600EDS sonde deployed alongside the AF Test Sonde and not protected. Growth completely disabled the sensors. Data was compromised at day 13 of the 17-day deployment. *Photo by Sherryl Gilbert, USF.*
